“The Effect of Low Velocity Impact Damage on the Performance of a Woven CFRP”

**Thesis submitted to the University of Sheffield for the Degree of Doctor of
Philosophy in the Faculty of Engineering and Materials.**

**Department of Mechanical and Process Engineering,
University of Sheffield,
Mappin Street,
Sheffield,
S1 3JD.**

October 1991

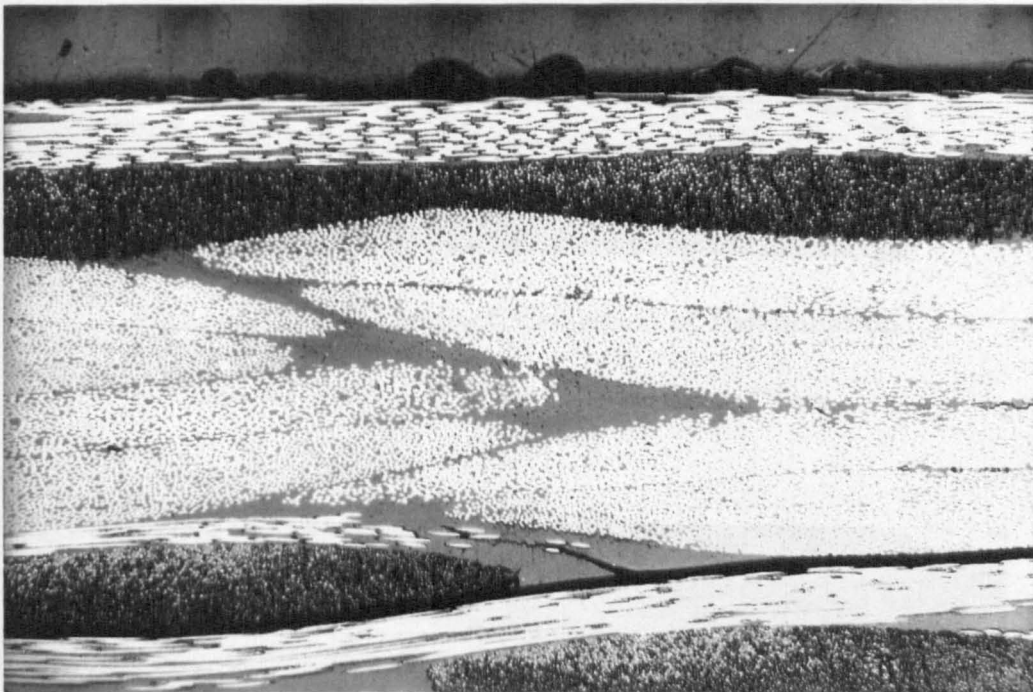
Figure 5.18. 2.94J Impact. The Influence of Tow
Cross-Overs in Deflecting Delaminations to
Adjacent Interfaces.

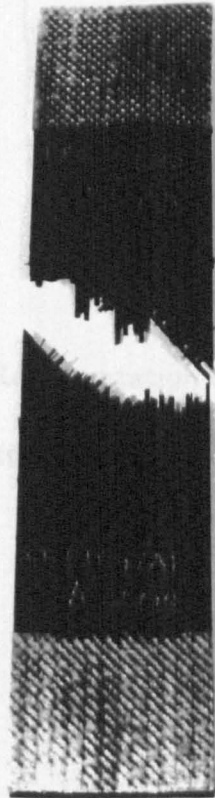
Figure 7.27. Typical High Stress/Low Cycle Zero-Tension

Fatigue Failure. Specimen LE6169/A1/B2/14, 2.94J,

$$\frac{\sigma_{max}}{\sigma_{rt}} = 0.80, N_f = 8338.$$

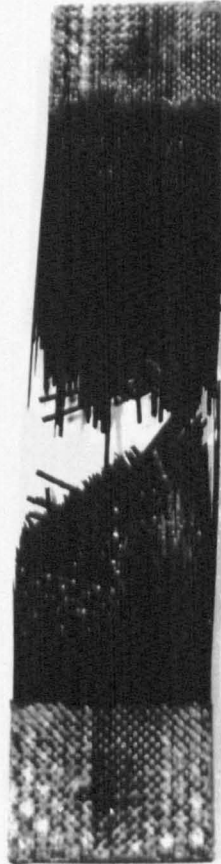
Figure 7.30. Typical Low Stress/High Cycle Zero-Tension
Fatigue Failure. Specimen LE6169/A1/B2/2, 2.94J,

$$\frac{\sigma_{max}}{\sigma_{rt}} = 0.50, N_f = 927870.$$

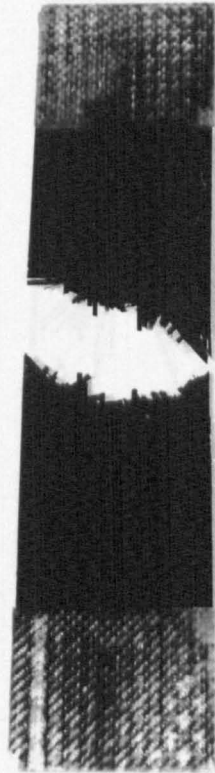
Figure 7.31. Typical High Stress/Low Cycle Zero-Tension
Fatigue Failure. Specimen LE6169/A1/B2/7, 6.87J,

$$\frac{\sigma_{max}}{\sigma_{rt}} = 0.80, N_f = 25291.$$

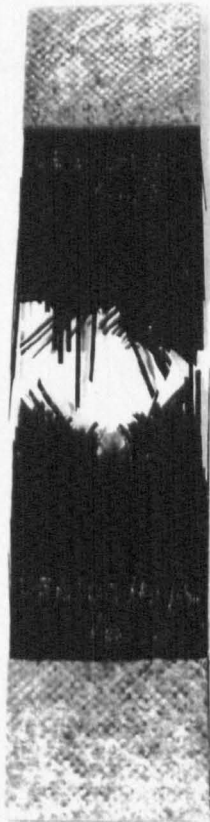
Figure 7.32. Typical Low Stress/High Cycle Zero-Tension
Fatigue Failure. Specimen LE6169/A1/A2/6, 6.87J,

$$\frac{\sigma_{max}}{\sigma_{rt}} = 0.60, N_f = 630920.$$
